Re: Compliance Evaluation Inspection of the Central District Wastewater Treatment Plant
Notice of Violation
National Pollutant Discharge Elimination System Permit No.: FL0024805

COMPLIANCE EVALUATION INSPECTION REPORT

Central District (Virginia Key) Wastewater Treatment Plant

NPDES Permit No. FL0024805

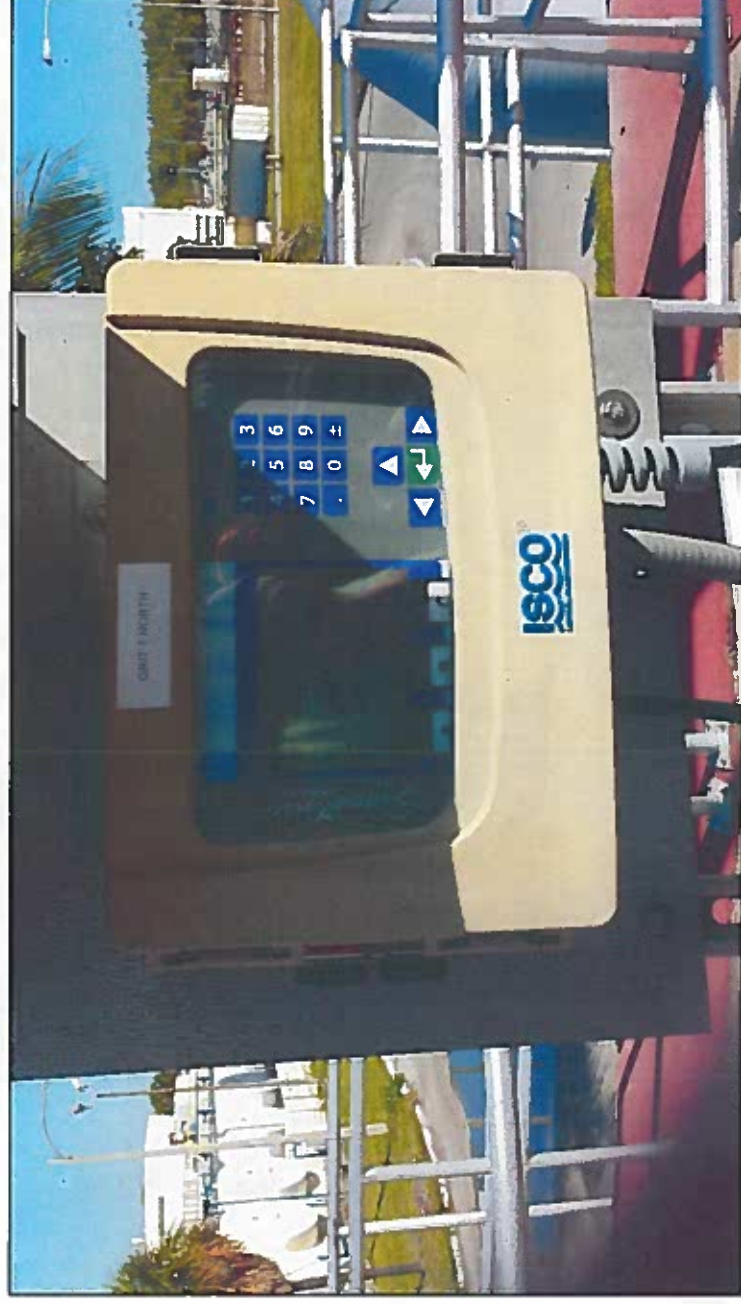
Flows enter Plant 1 of the CDWWTP from the mainland/downtown Miami via the 4th Street Pump Station and the 9th Street Pump Station through either the 72" or the 102" joint force mains. Both of Plant 1's influent aerated grit chambers were in service during the inspection. Flow at the northern grit chamber of Plant 1 was metered at 31.4 MGD (10:01 am), but Mr. Saint-Phard noted that the influent flow meters are not used for reporting purposes due to the inaccuracies when the flumes are submerged. Thus, the County adds up the flows from the incoming pump stations (i.e. 4th Street PS; 9th Street PS; Miami Beach PS; Key Biscayne PS; and a few others) to calculate the influent flows to the CDWWTP. The EPA subsequently noted that Mr. Saint-Phard told the EPA that the County had recently completed adjusting weirs that prevents submersion of the grit chamber flumes during last year's CEI. *See enclosed photo.*

Plant 1 influent flow meter display (northern grit flume)

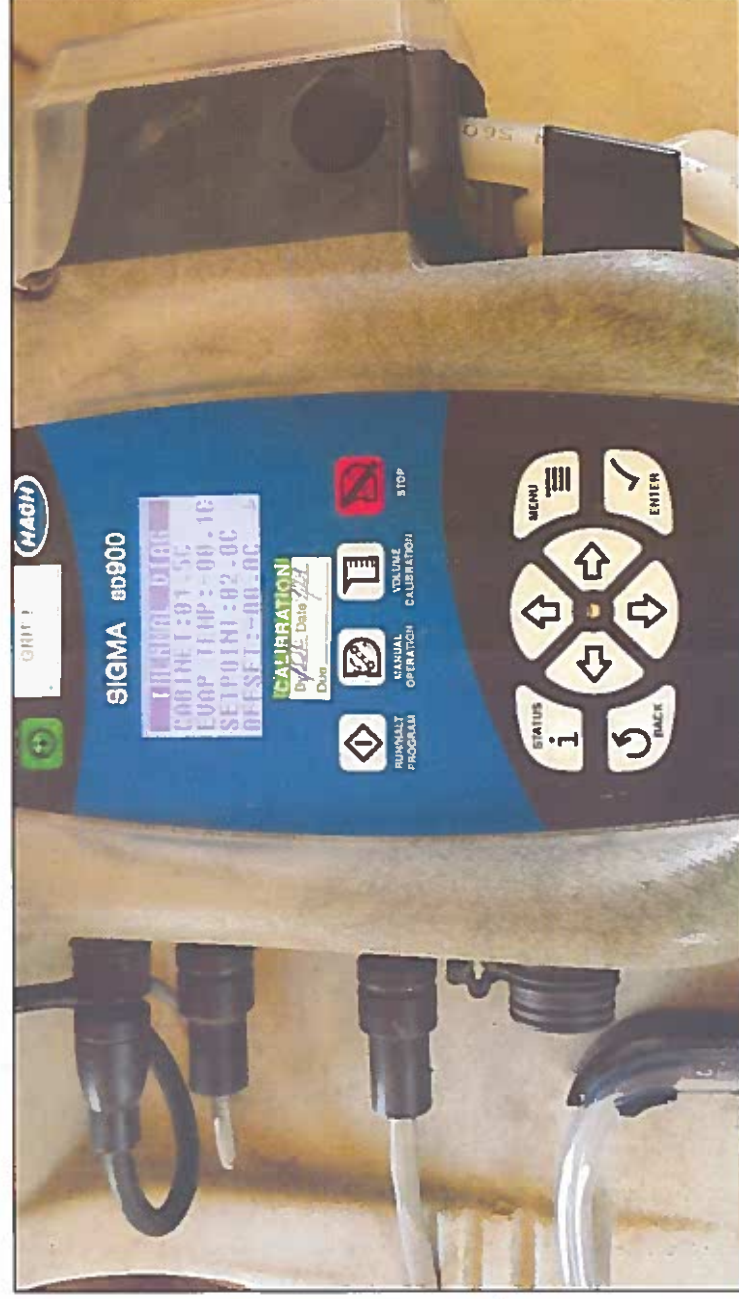
While inspecting the influent automatic sampler in Plant 1's headworks, Mr. Saint-Phard told the EPA and FDEP that both influent automatic samplers (for Plant 1 and Plant 2) are time composite (i.e. the sampler pulls a 200 mL sample every hour), whereas the effluent automatic sampler is flow composite. According to County staff, parts arrived the day before this CEI to convert both of the influent automatic samplers to flow composite. *See enclosed photo.*

Plant 1 influent automatic sampler display

Deficiency/Recommendation: While the EPA-issued NPDES permit only requires a 24-hour composite sample, it is a concern that Miami-Dade has time-composite samplers to monitor influent while it has flow-composite sampler for monitoring effluent. This is inconsistent compositing and could impact monitoring results (e.g. for % removal calculation). The EPA encourages Miami-Dade to install whatever equipment to make all compositing consistent and suggests that Miami-Dade conduct flow-composite samples for all influent and effluent.

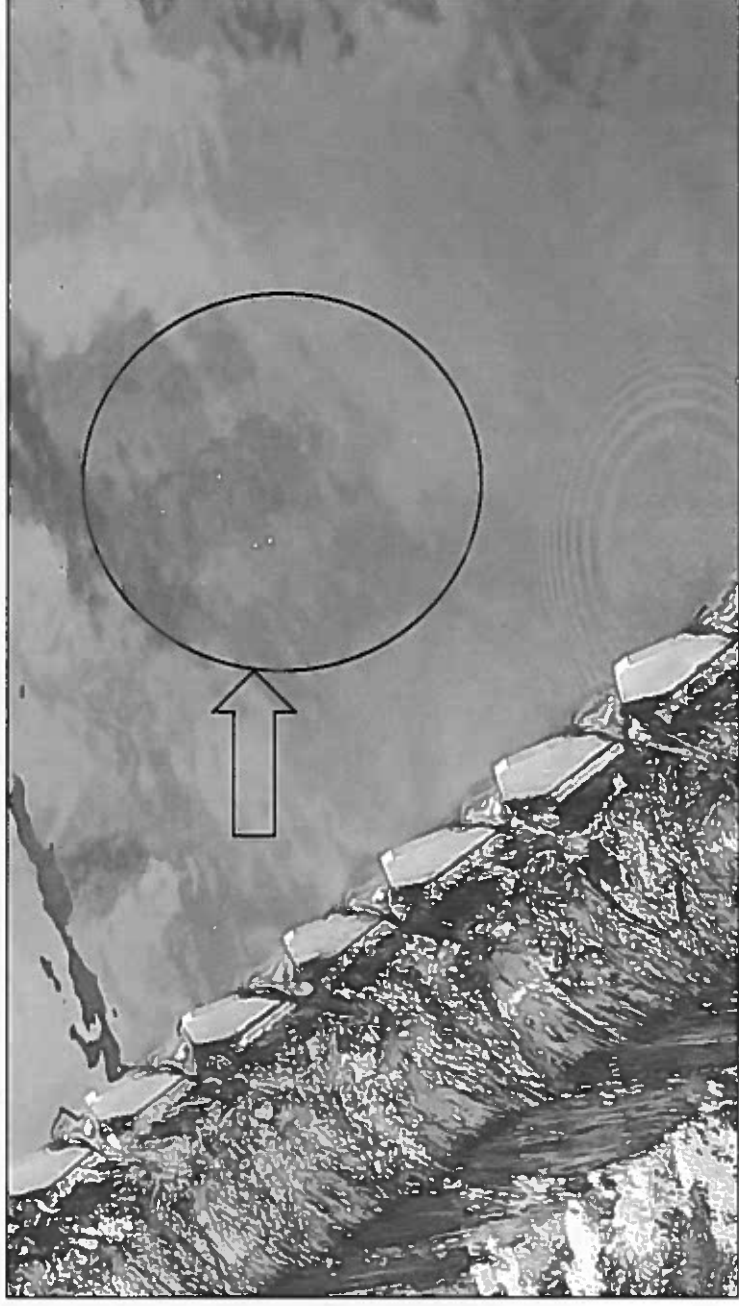
The EPA observed less scum as well as less algae on the weirs in the Plant 1 final settling tanks than during previous inspections. While scum, algae, debris and trash appeared to be less than in previous inspections, the amount of pin floc being discharged out the ocean outfall was greater than seen in the past and is a concern. *See enclosed photo.*

Plant 1, final settling tank #4C (note heavy flocculation)

Violation/Recommendation: Part II, Section B.1. of the EPA-issued NPDES permit requires the permittee to "...at all times properly operate and maintain all facilities and systems of treatment and control (and related appurtenances) which are installed or used by the permittee to achieve compliance with the conditions of this permit." Miami-Dade violated this provision due to the large amount of pin floc being discharged to the Atlantic Ocean.

Miami-Dade should explain why the final settling tanks are experiencing such large amounts of pin floc that is being discharged (e.g. sludge age and/or blanket depths; not enough sludge wasting due to out of service sludge digesters, etc.). All of the trash, floatables, algae and floc are likely to be discharged through the outfall into the Atlantic Ocean.

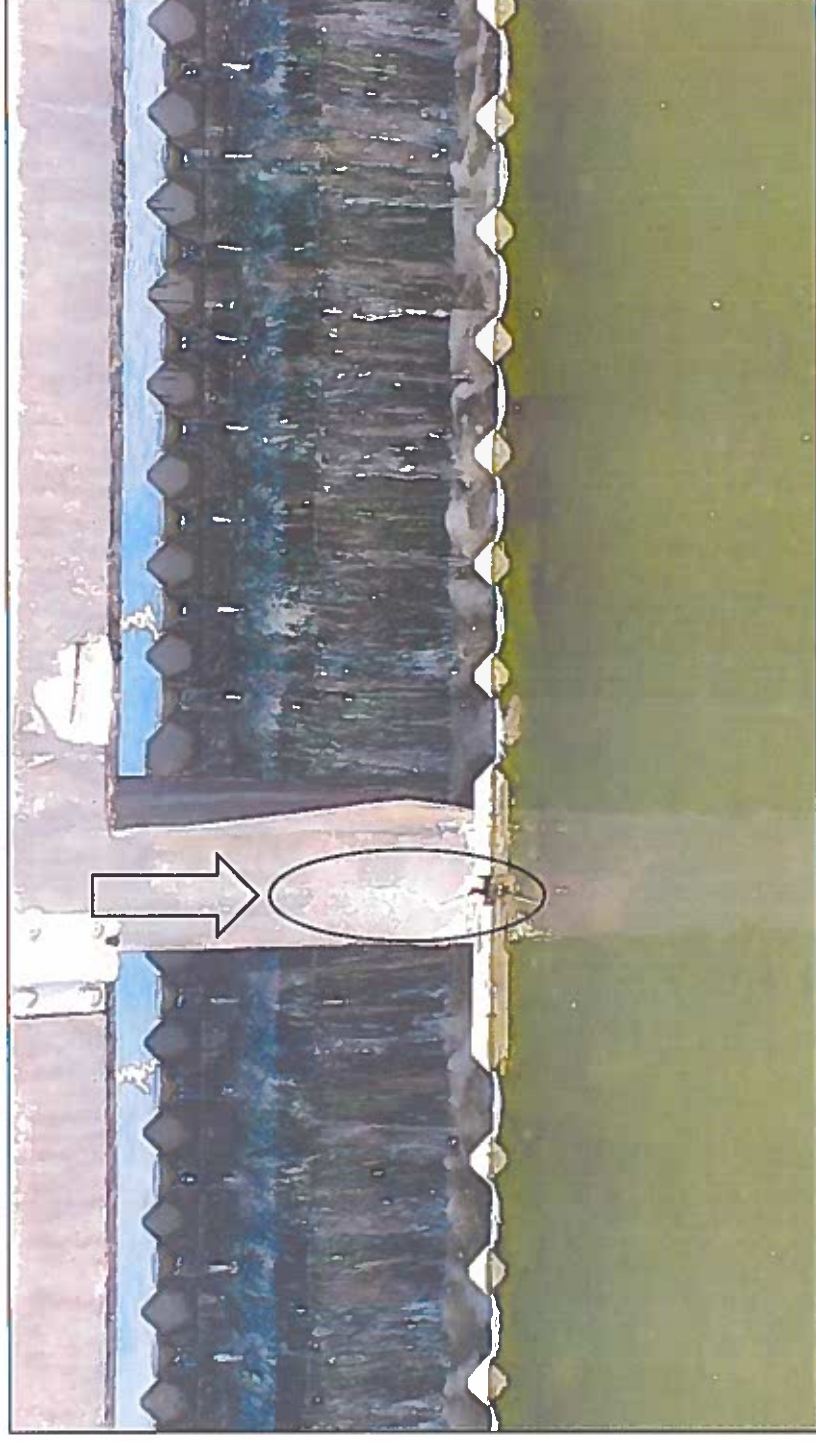
The EPA noted several locations in the walkways between the final settling tanks that had structural cracks in the concrete all the way through the walkway and/or support columns to the walkway in Plant 1 (e.g. walkway along final settling tank #4B). *See enclosed photo.*

Plant 1, Final settling tank #4B (note structural crack in walkway support)

Deficiency/Recommendation: The structural cracks in the walkways may present a safety hazard to workers and compliance inspectors should the walkways fail while in use. Miami-Dade should thoroughly inspect and address walkways with structural risks and implement all structural repairs pursuant to the deadlines in the new Consent Decree.

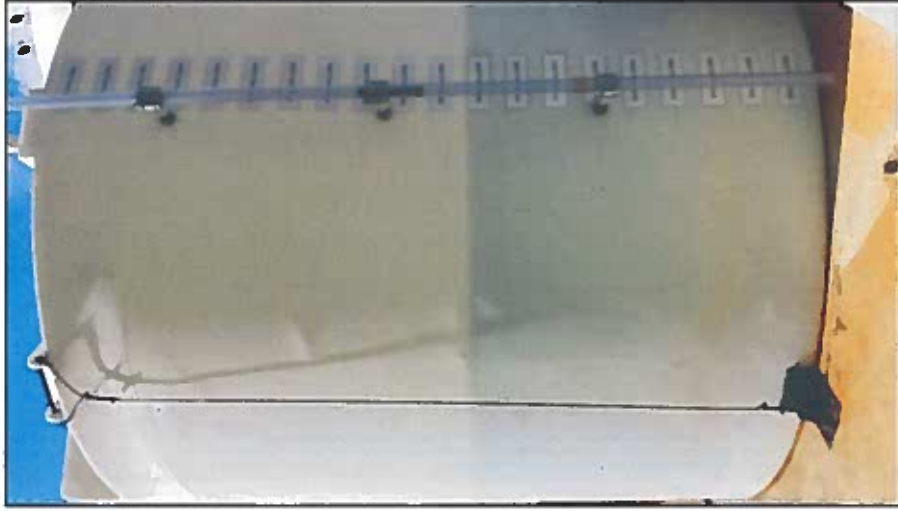
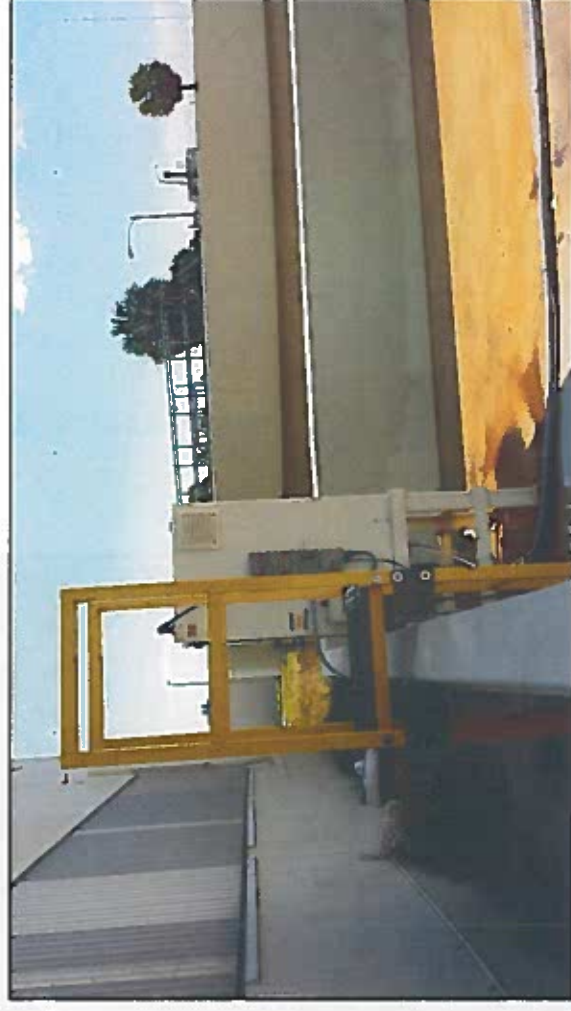
Ferric Chloride is fed into a valve box outside the Sludge Dewatering Building (prior to adding polymer) to decrease struvite creation. The two ferric chloride tankers in temporary containment that were observed outside of the sludge dewatering building during last year's CEI had been removed and a permanent ferric chloride tank (with secondary containment and controls) has been installed. *See enclosed photos.*

Ferric Chloride permanent tank with containment and controls outside sludge dewatering building

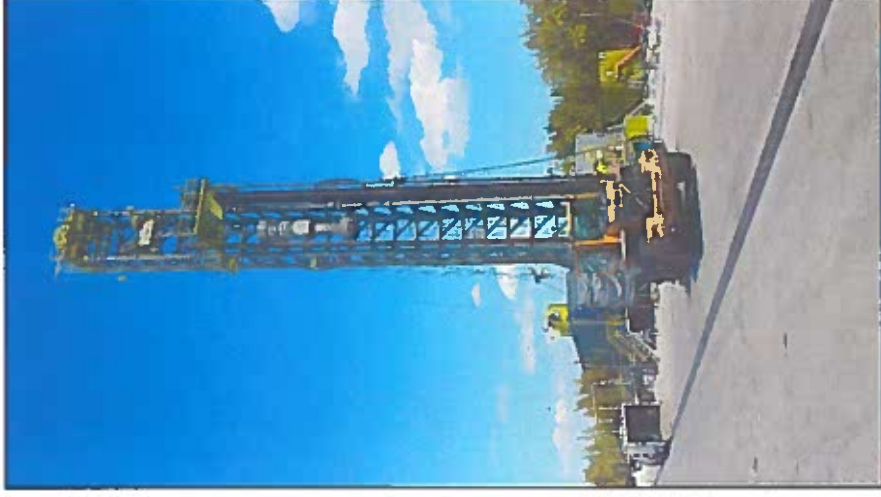
Behind the sludge dewatering building, an area has been fenced off for drilling of an exploratory well that will potentially be used for injection of treated wastewater for the County to comply with the State's Ocean Outfall Legislation. At the time of this CEI, the well had been drilled to just over 1,000 feet deep. Ed Rectenwald (County drilling consultant) told the EPA that the well will eventually be over 10,000 feet deep and will have a 5,000 psi blowout preventer. Mr. Rectenwald told the EPA and FDEP that they expect that the well's injection zone will still be an estimated 2,000 feet above any oil or gas. When asked what they plan to do with the groundwater during well construction, it was noted that the ultimate plan is to hold the water, test

it for chlorides and if the chlorides are not too high, will send the water to the headworks of the CDWWTP for treatment and ultimate discharge out the ocean outfall. *See enclosed photo.*

UIC exploratory well drilling (east of sludge dewatering building)

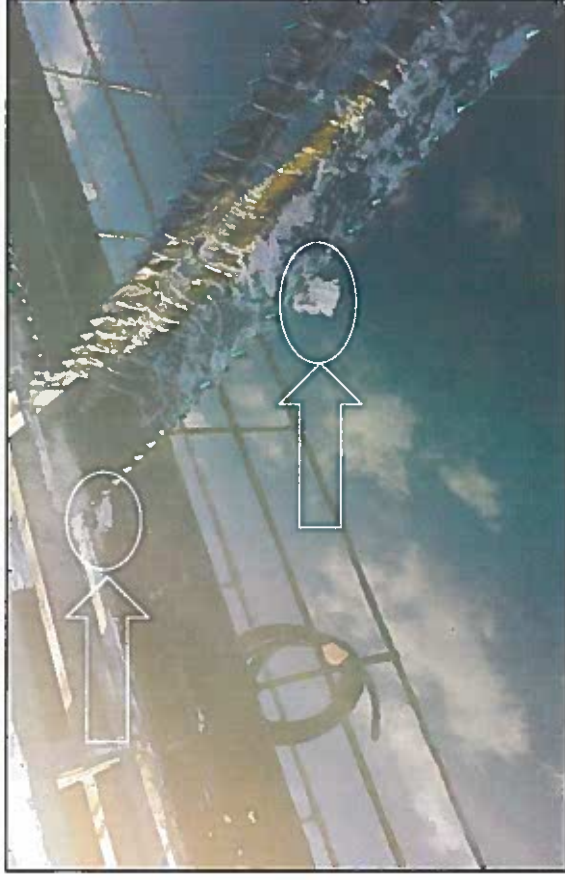
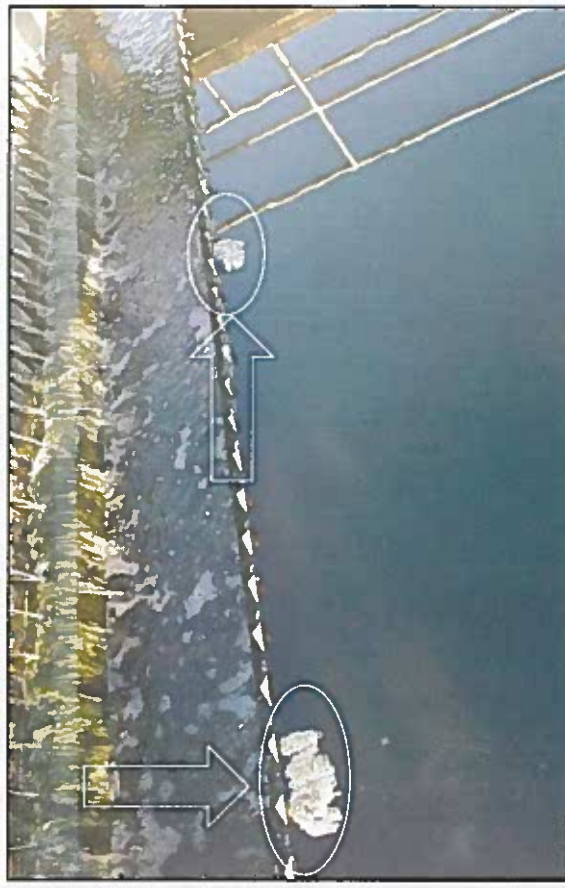
In the final settling tanks/secondary clarifiers of Plant 2, the EPA observed some algae and large floatables, trash/debris (e.g., plastic trash), unsettled floc and large amounts of pin floc. [See the enclosed photos.](#)

Plant 2, Final settling tanks #7A (Left) and 7B (Right) (note floatables)

Violation/Recommendation: Part II, Section B.1. of the EPA-issued NPDES permit requires the permittee to "...at all times properly operate and maintain all facilities and systems of treatment and control (and related appurtenances) which are installed or used by the permittee to achieve compliance with the conditions of this permit." Previous EPA inspections have noted similar trash, floatables, algae and pin floc in the final settling tanks/secondary clarifiers.

Miami-Dade should explain why the final settling tanks are experiencing such large amounts of pin floc that is being discharged (e.g. sludge age and/or blanket depths; not enough sludge wasting due to out of service sludge digesters, etc.) through the outfall into the Atlantic Ocean.

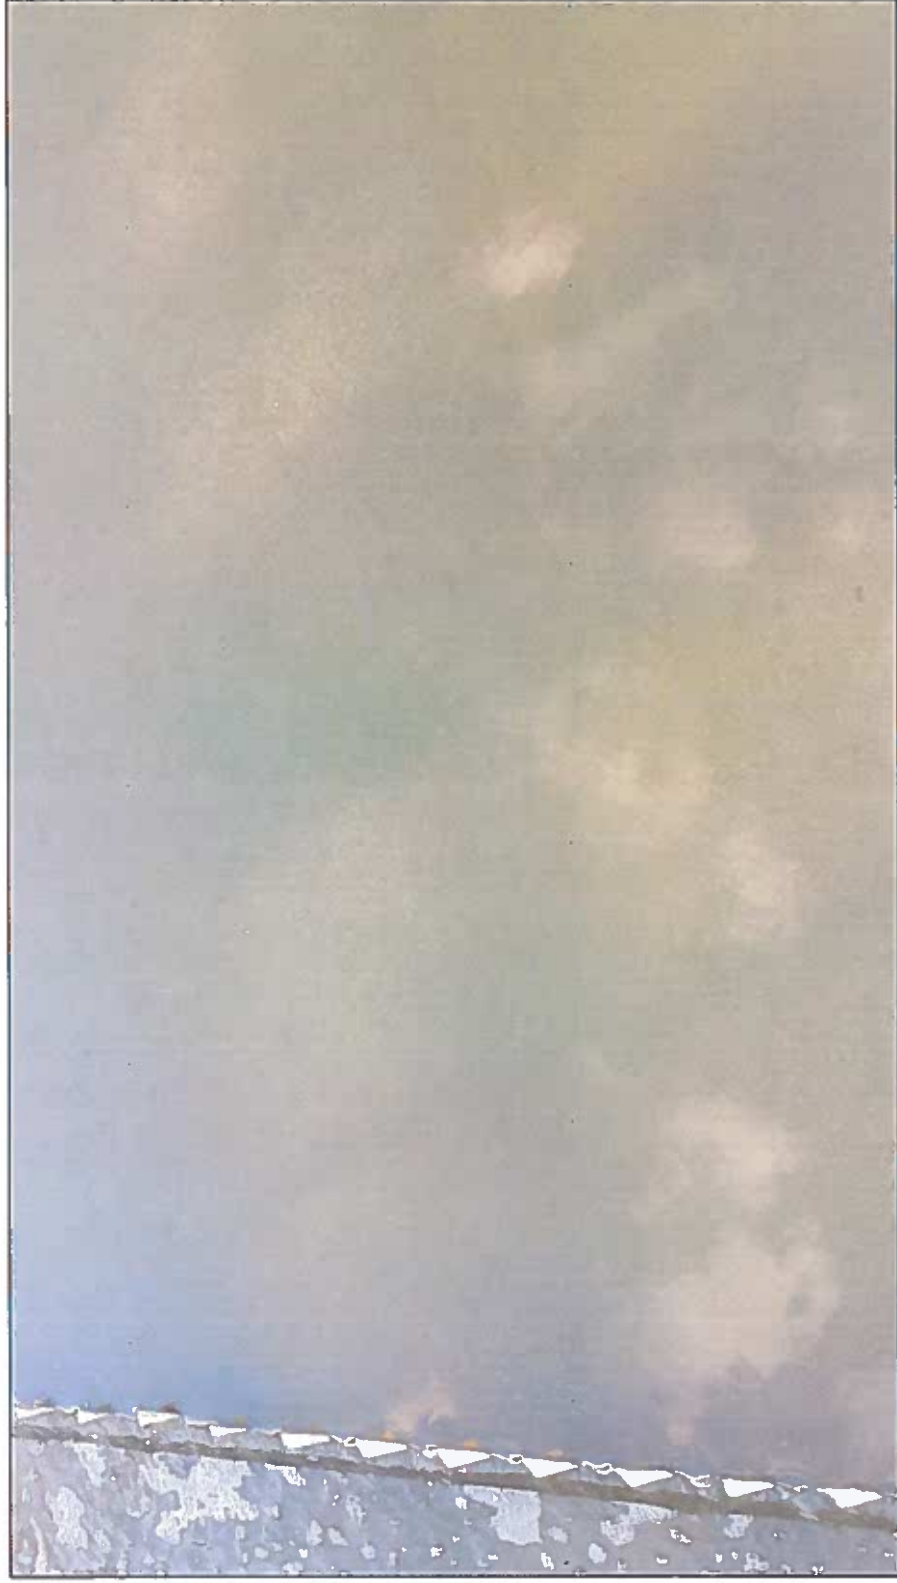
Plant 2, Final settling tank #7B (note heavy flocculation)

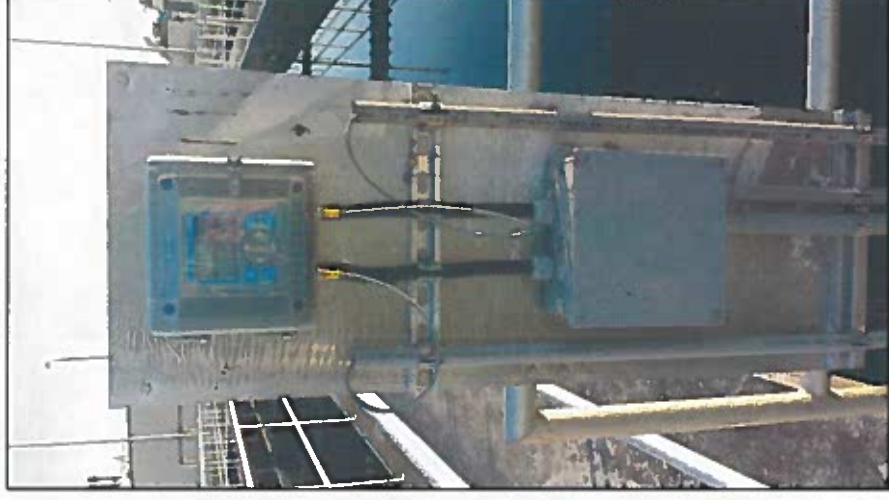
The EPA did observe that new sludge blanket meters have been installed for all 10 of the Plant 2 final settling tanks. Mr. Saint-Phard told the EPA that all of the sludge blanket meters had been installed in both Plants. *See enclosed photo.*

Plant 2, Sludge blanket meter at Final settling tank #9B for tanks #9 and 10

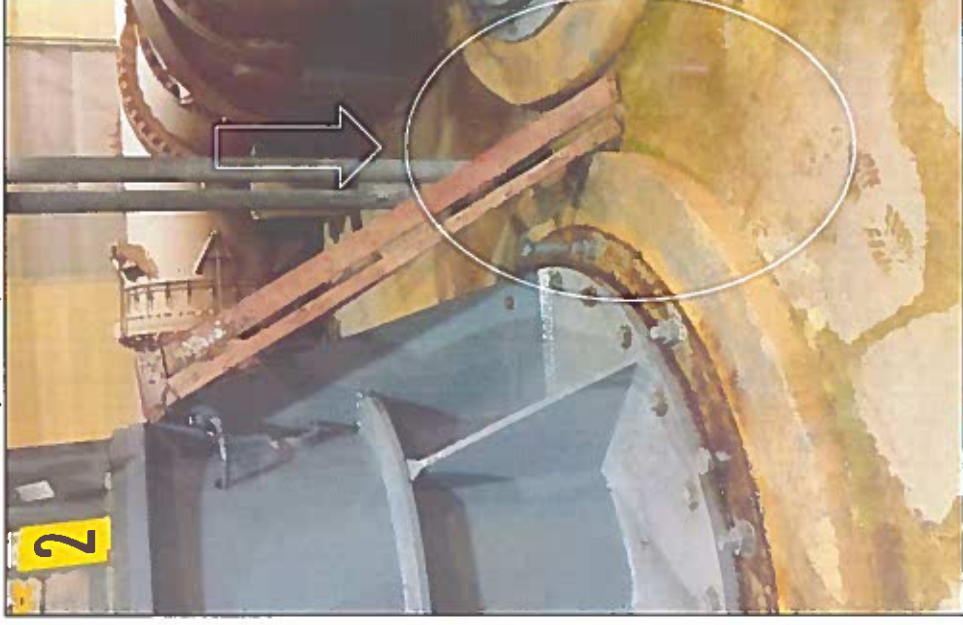
Effluent pump #2 had been overhauled and placed back into service on 12/9/2014 according to Mr. Saint-Phard. The EPA observed a seal leak at this pump during this CEI. See enclosed photo.

Effluent Pump Station, Pump #2 (note seal water leak on floor)
